# VIBRATION DAMPER FAILURE AT THE GENERATOR

TECHNICAL INFO NO. 1957

Nissan: Almera, Micra  
 Renault: Clio II + III, Scénic, Grand Scénic, Kangoo, Mégane II

Nissan 1.5 DCI (1/2002→)  
 Renault: 1.5 DCI (2003→)

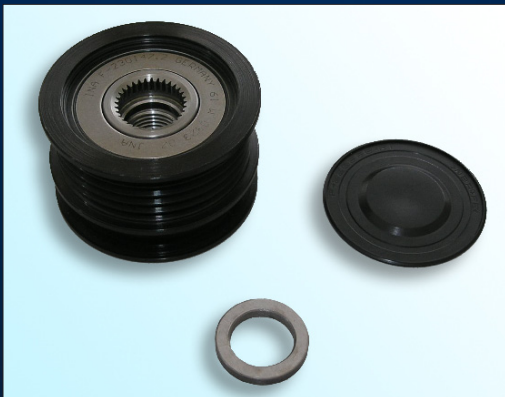
Picture 1: Overrunning alternator pulley 56334

On a defective vibration damper the rubber has come loose from the metal parts resulting in the loss of the damping function.

Alternatively, RUVILLE offers an overrunning alternator pulley (56334).

In response to their repeated failure during operation, we recommend that the original equipment vibration dampers be inspected, and replaced if necessary, whenever the car is serviced.
