**EGON VON RUVILLE GmbH**

# FAILURE DIAGNOSIS RADIAL AND AXIAL JOINTS

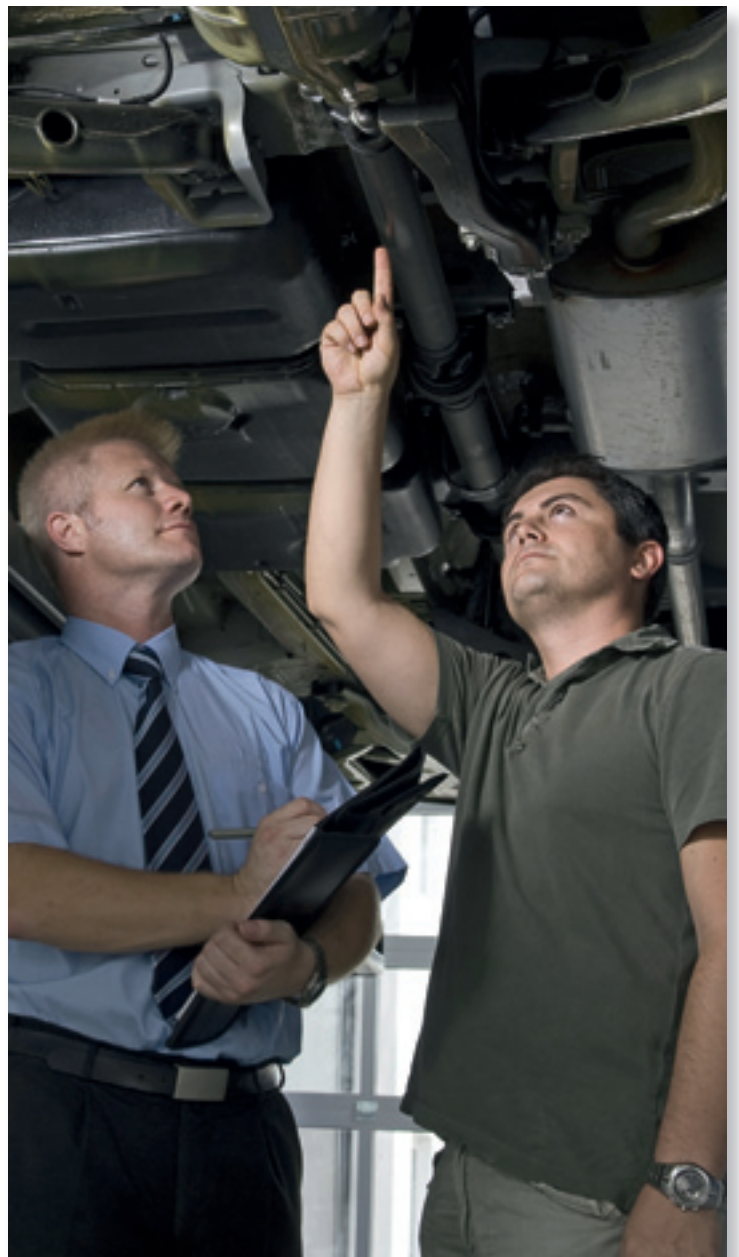
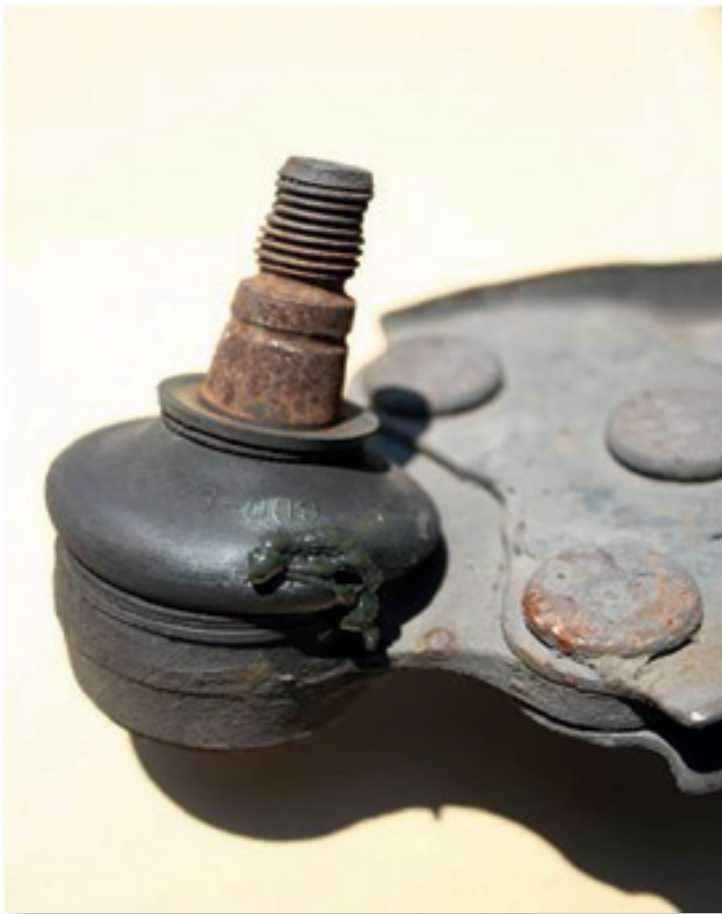
- Defective dust boot
- Eroded ball socket
- Extracted ball joints
- Rusty joints

- Wear limits have been exceeded
- External impact
- Insufficient lubrication
- Contamination by dirt or moisture
- High mechanical stress
- Incorrect wheel/tyre combination

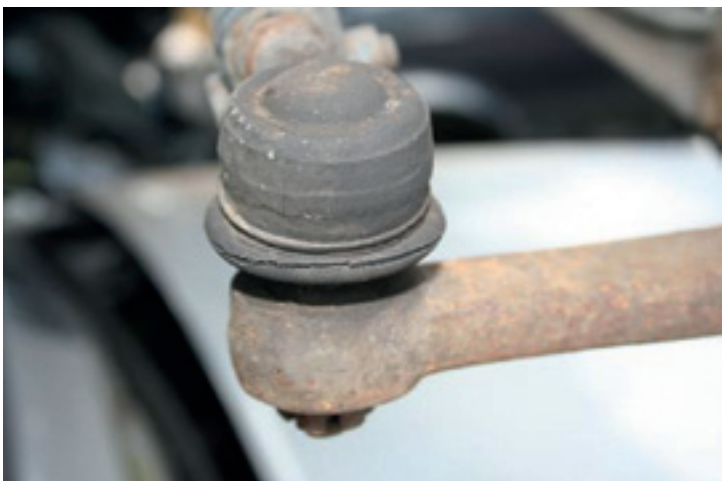
To check for ball joint damage (positions 1-3 in the picture) the mechanic simulates possible movements of the component in question, i.e. its movability in horizontal and vertical direction.

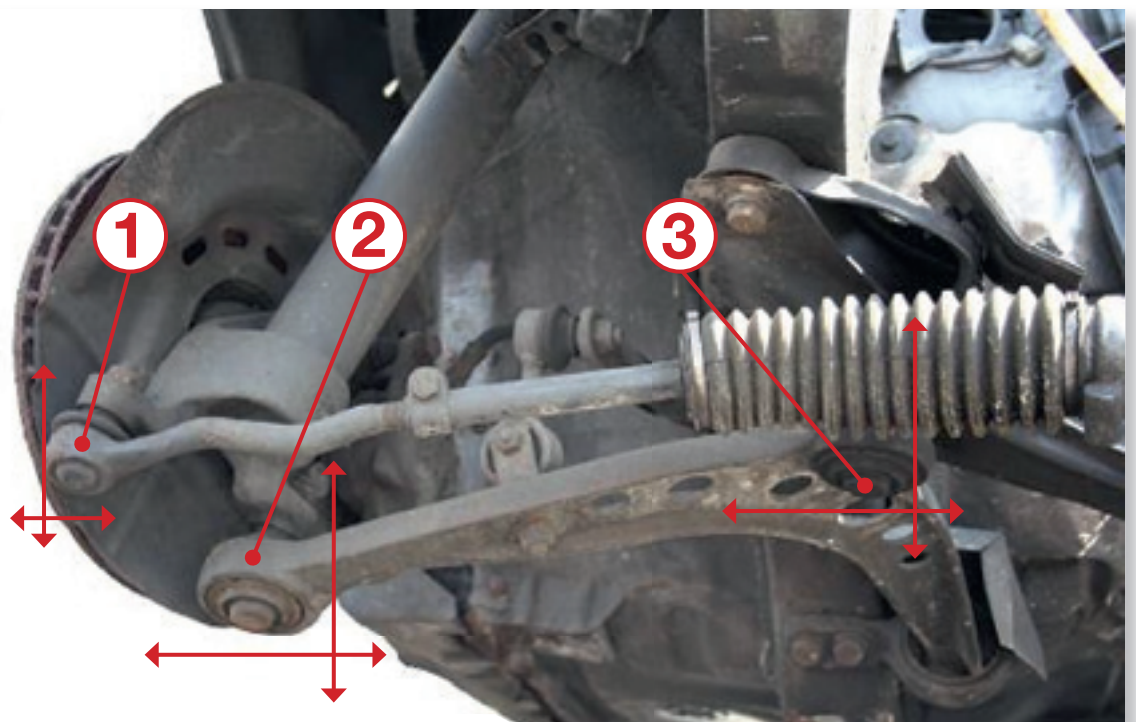
Loose joints can be identified by visual inspection, but more reliably by touching.

Use slip joint pliers or a tyre lever to offset components from one another. Proceed with utmost caution so as not to damage the rubber boots.

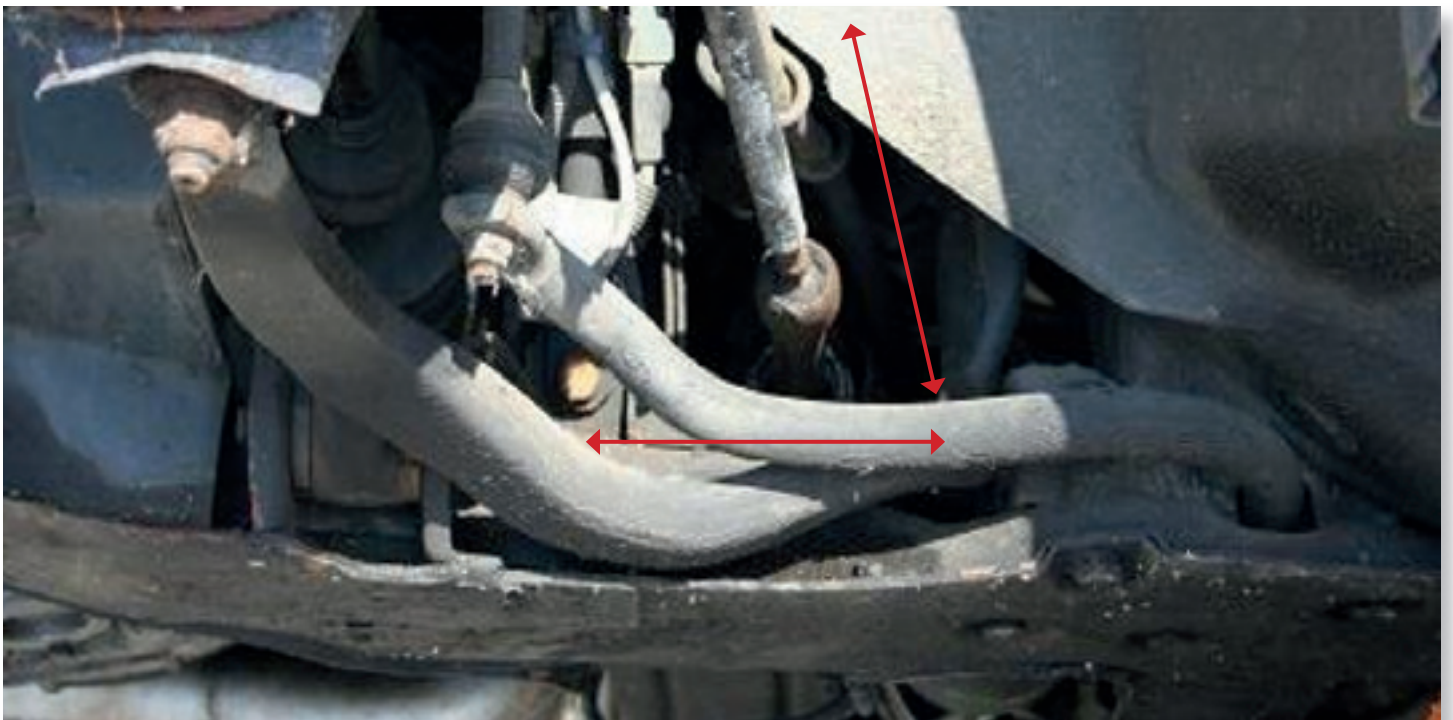
On rack-and-pinion steering systems the tie rod is firmly bolted to the steering gear by its inner end.

Flexible connection between the steering gear and tie rod is ensured by means of an axial joint which is subjected to highest stress, as both compression and tensile loads are applied. This means that ball head and socket must match precisely.

If excessive clearance is observed on one of the components forming the steering trapeze, immediate detailed inspection is imperative as these components are critical for vehicle safety. This cannot be emphasized strongly enough.

To locate a defective axial joint and pinpoint the cause it may be necessary to remove the steering joint bellows as this is the only way to rule out the risk of replacing a fully functional steering gear.

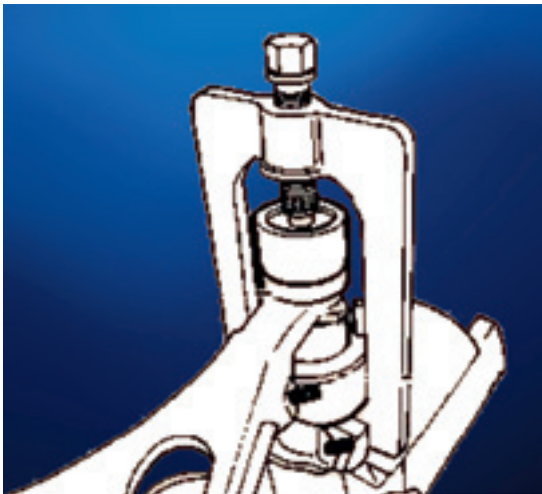
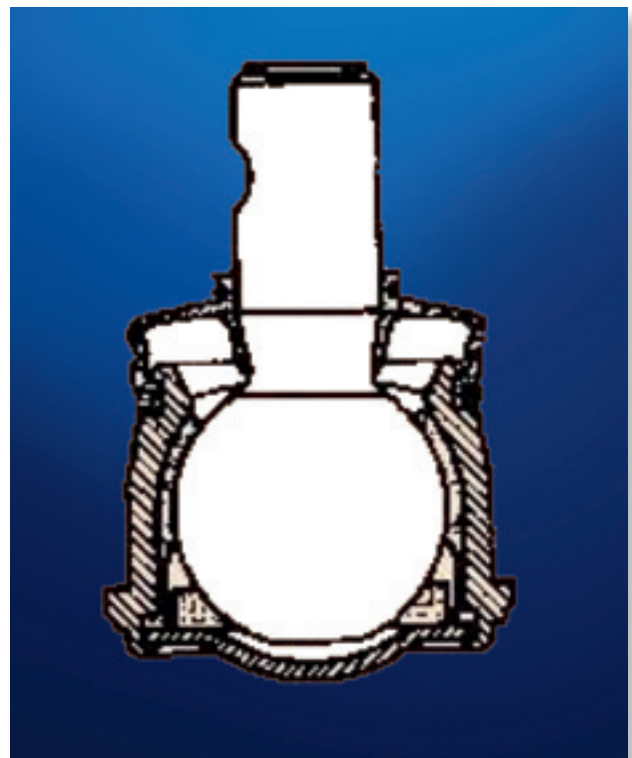
Place the control arm in installation position in the tool and press downward to drive out the support joint. Make sure there is sufficient space for the used part in the lower area of the press.

To remove support joints use a mechanical extracting tool or a customary hydraulic press with attachments.

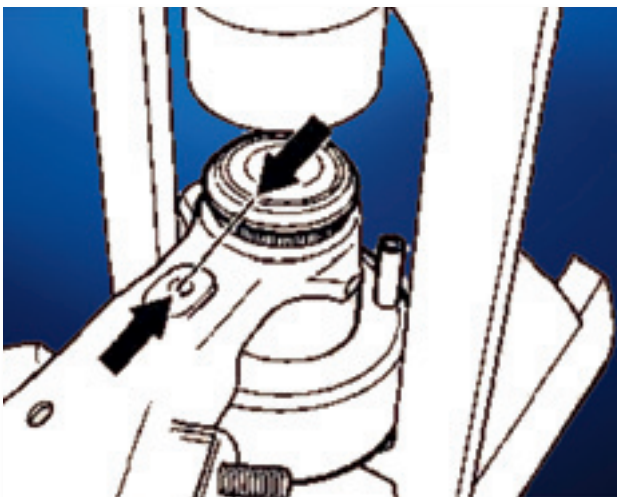
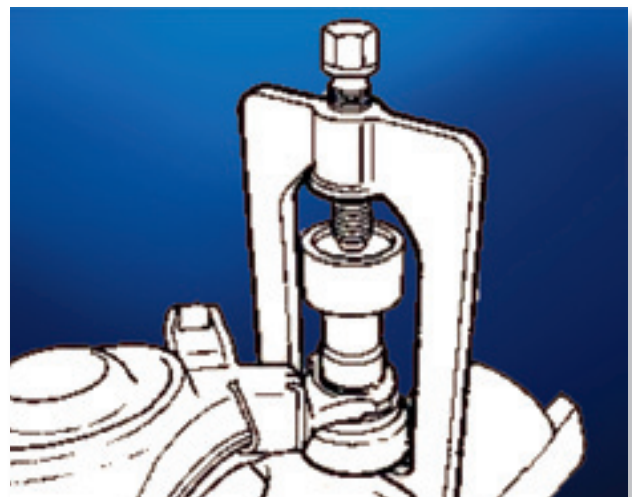
To install the new support joint place the control arm against its installation position in the tool.

To ensure trouble-free operation align the marks on the control arm with the marks on the support joint.

When the correct installation position is ensured use a clamping pad to press the support joint in the control arm.

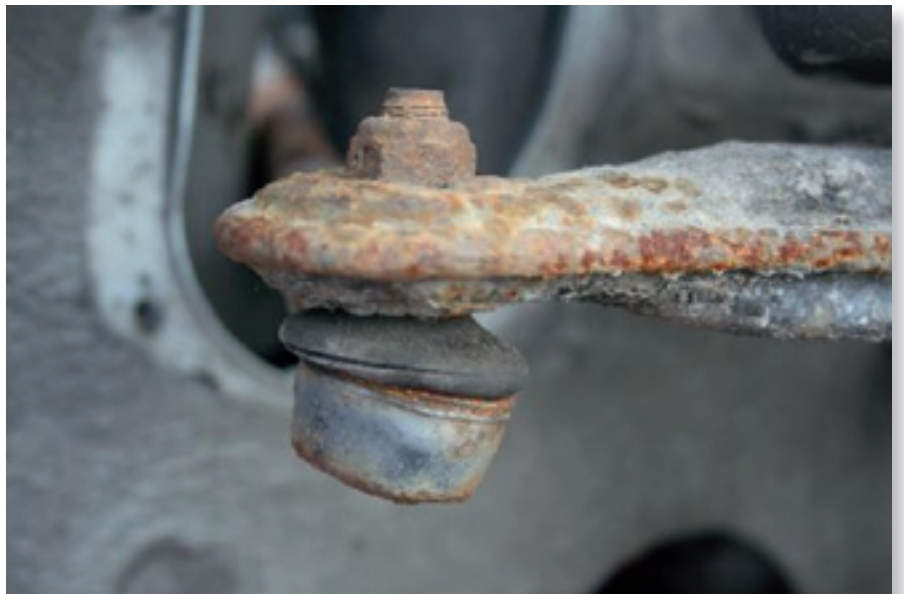
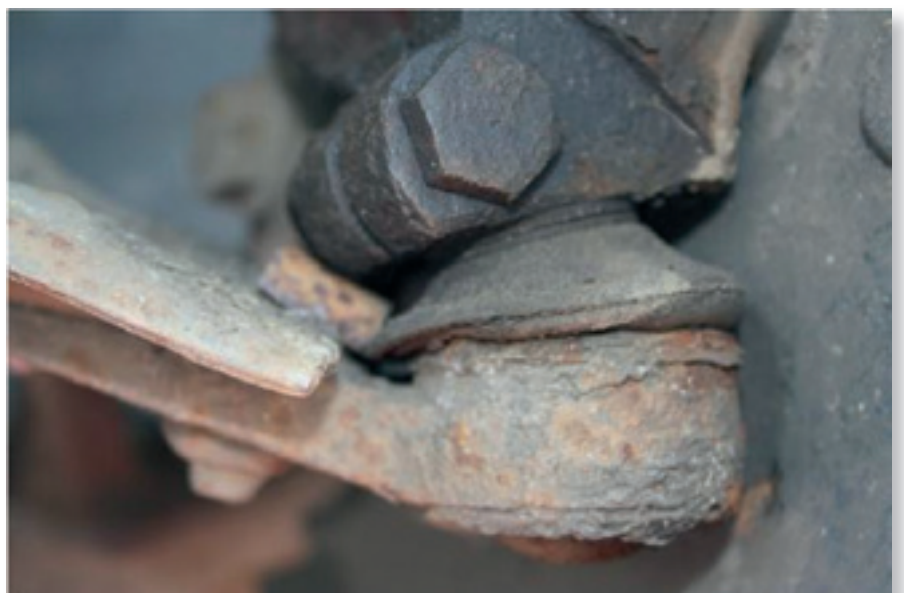
Porous or torn rubber boots on tie rod ends and axle joints allow moisture and dirt to enter the joints which causes increased wear of all components.

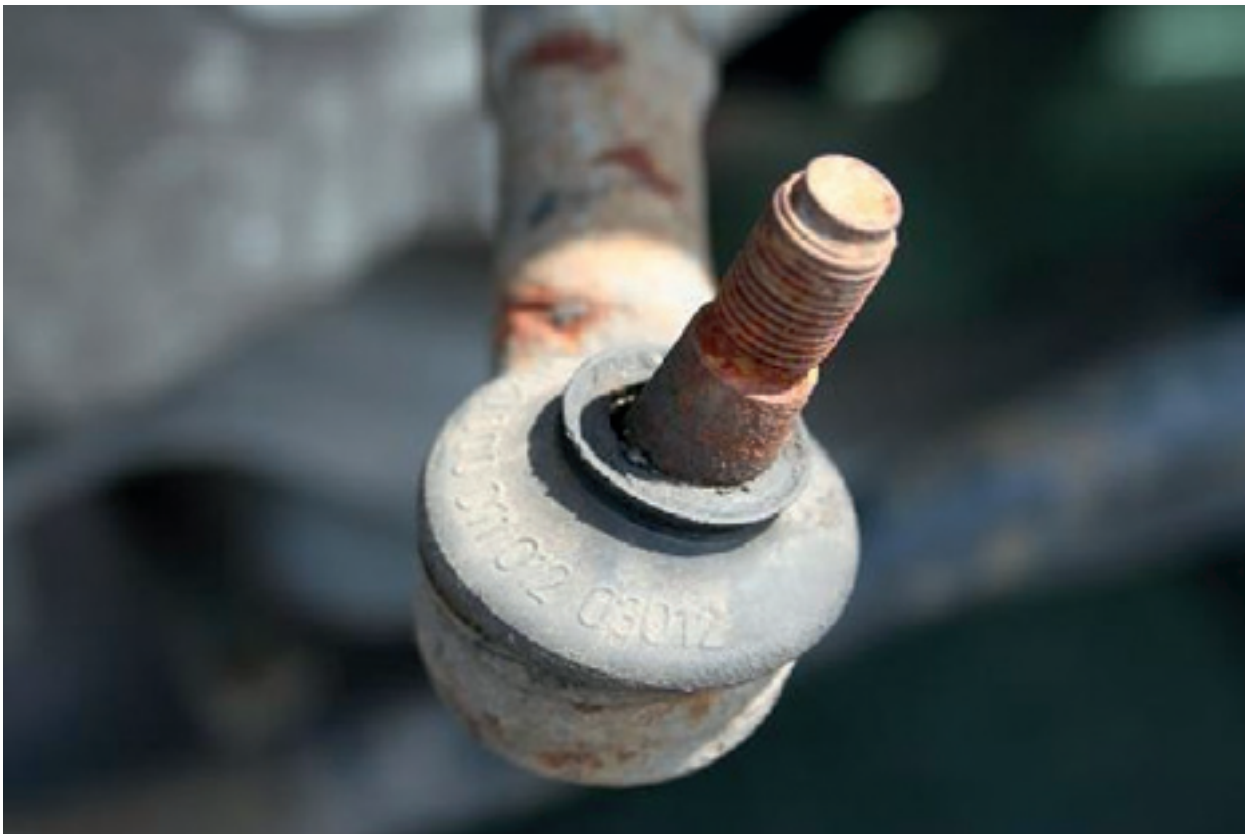
Lost snap rings can also allow contaminants to penetrate into the ball head. The result: excessive ball head clearance will destroy the ball socket within shortest time.
