ARTICLE INFORMATION ON OVERRUNNING ALTERNATOR PULLEY 55627

TECHNICAL INFO NO. 1005

Dacia, Renault

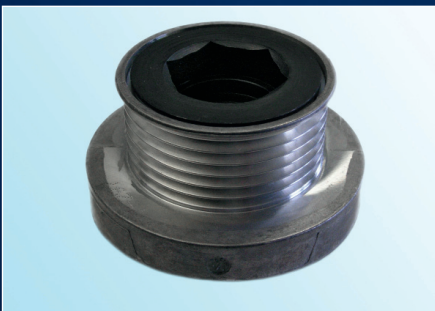
Fig. 1: Alternator Belt Pulley 77 00 110 616

Should the alternator belt pulley be defective (OE ref. 77 00 110 616), it is to be replaced by an overrunning alternator pulley. The overrunning alternator pulley is available with RUVILLE No. 55627.

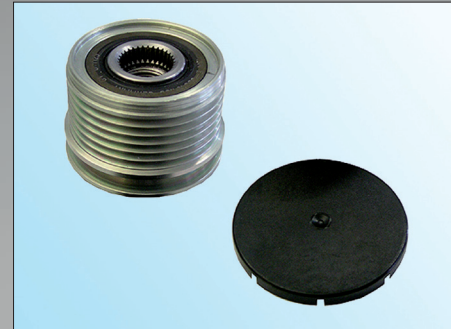
Fig. 2: Overrunning Alternator Pulley RUVILLE 55627

1 x overrunning alternator pulley
1 x sealing cap

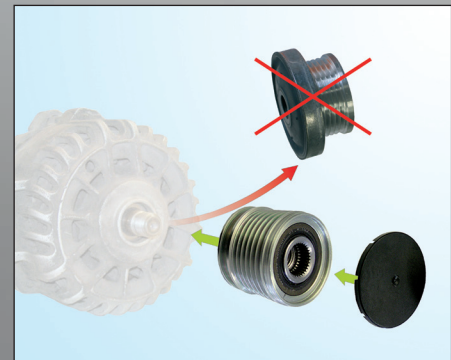
Fig. 3: Replacement procedure

1. Slacken tensioner and remove poly V-Belt
2. Check all belt drive components for damage - replace damaged components
3. Remove the original belt pulley from the alternator (see Fig. 3)
4. Assemble the Overrunning Alternator 55627 with the relevant special tool.
5. Assemble the seal cap on the Overrunning Alternator Pulley
– Ensuring it is seated correctly and is a tight fit!
6. Assemble the poly V-Belt
